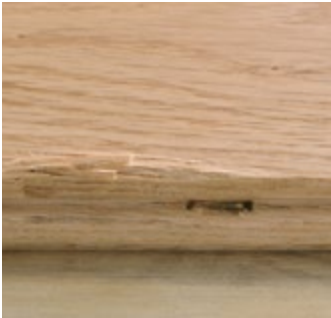
Air-hammer nailer held at the wrong angle

In this illustration, an air-hammer held at the wrong angle may damage the side of a board, which could lead to small splits appearing along the surface of the side of the board immediately or later.

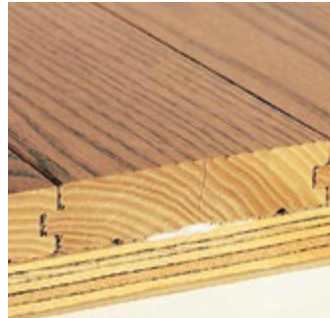
Piece of plaster left under the subfloor

This illustration shows what happens when a piece of dried plaster remains on a subfloor. The subfloor should be inspected carefully and bits and pieces of dried plaster removed before laying down wood flooring to avoid undue stress on boards that may eventually crack, especially in the middle.

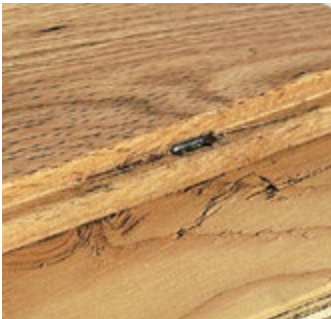
Staples driven in too deeply

This illustration shows a staple driven in too deeply. As a result, cracks may appear on each side of the staple. The cracks may follow the wood grain right up to the surface of the board.

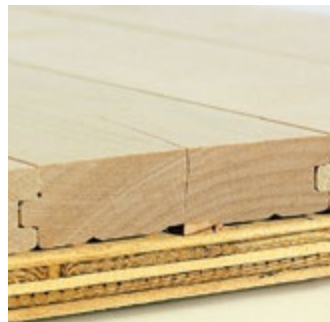
Sliver of wood left between boards and the subfloor

In this illustration a small sliver of wood has been left between the boards and the subfloor. This situation can lead to undue stress on boards that may crack right away, or perhaps later. It is very important to clean the subfloor before laying down wood flooring.

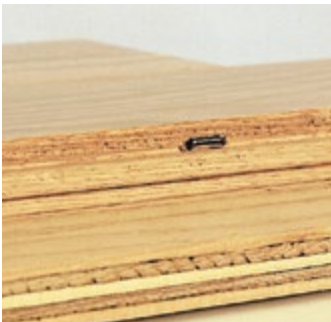
Staples not driven in deeply enough

This illustration shows a staple not driven in deeply enough. This will impede a perfect assembly, which will damage the next board laid down. Moreover, since the boards are not properly secured in place, the floor will creak when walked on and cracks may even appear in one or more of the boards.

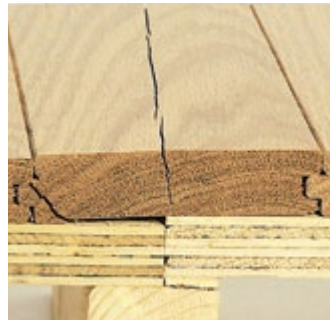
Uneven subfloor

This is an illustration of an uneven subfloor. Boards laid down on an uneven subfloor can cause boards to crack immediately or later.

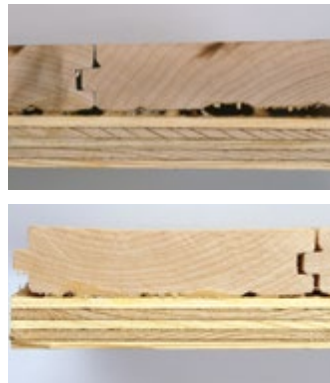
Boards glued down full-length with a water-based adhesive

This shows boards glued down full-length with a water-based adhesive. As you are aware, water and wood are not compatible. The water has caused the wood to swell underneath, and it will remain so even after drying.
